MIT Rocket Team LOX Tank

16.622 Final Project Report Massachusetts Institute of Technology

Authors: Christine Edwards and Selim Sumer Advisor: Col. John E. Keesee May 10, 2005

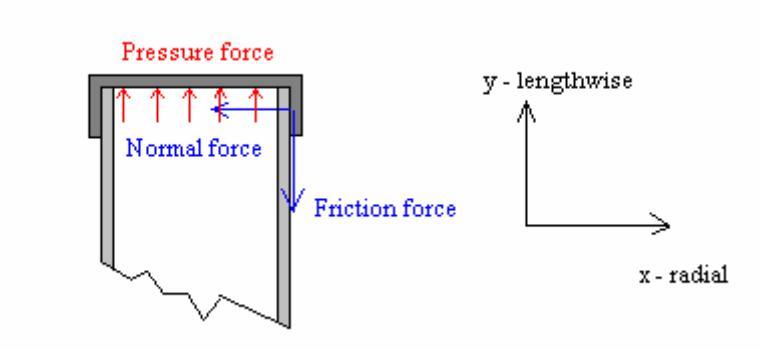
- 1. Stress in the walls less than yield strength when pressurized at 200 psi.
- Friction force is large enough to hold pressure force when pressurized at 200 psi (See Figure 4.2-1)

Figure 4.2-1: Forces acting on cylinder and end-cap

Table A-1 shows the output of our analysis program for one of the caps that does not bond Kapton. The calculated forces correspond to those in Figure 4.2-1, and the dimensions correspond to those in Figure A-2.

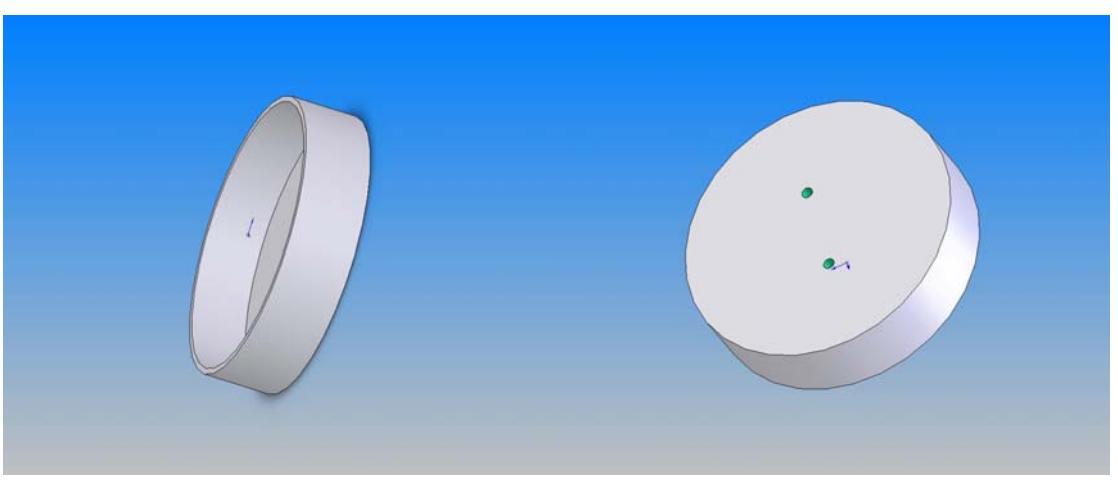
To establish tank dimensions that satisfied these criteria, an Excel program was used to measure stresses and forces on the tank. This program is shown in Appendix A, and the engineering drawings of the end caps are given in Appendix B. An isometric view is shown in Figure 4.2-2.

Figure 4.2-2 Isometric view of the end-cap design

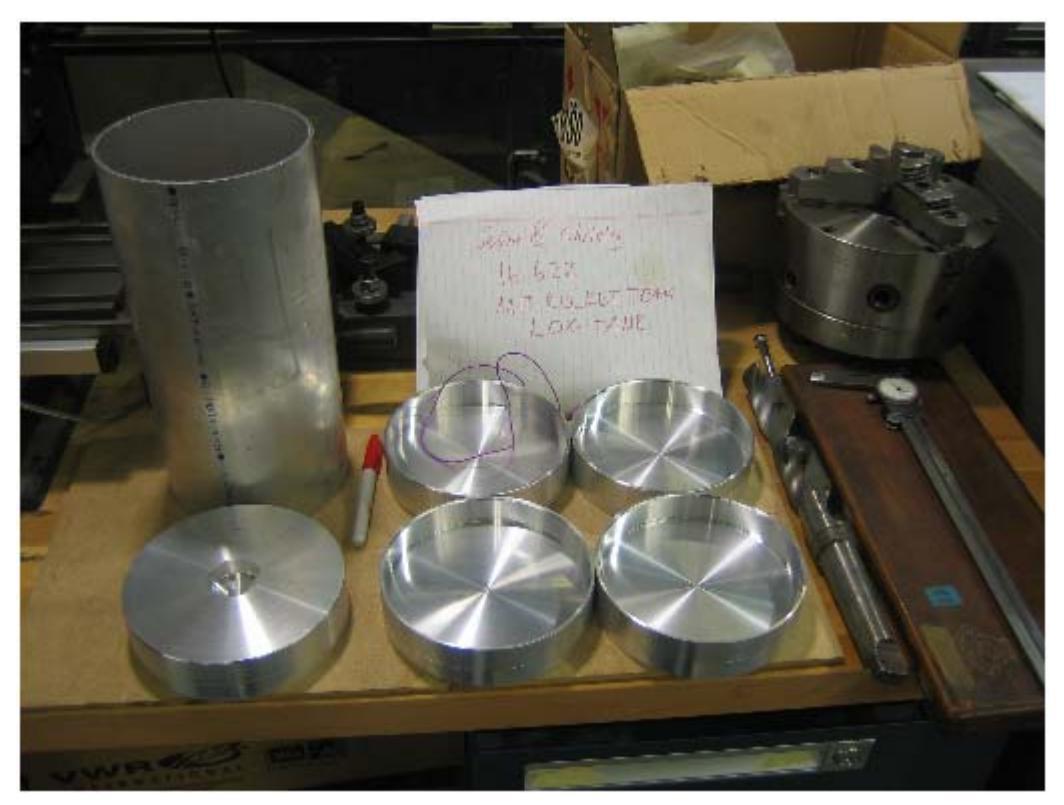
Figure 4.3-1 The figure shows the four end-caps and a prepared spare disc after final step in lathe

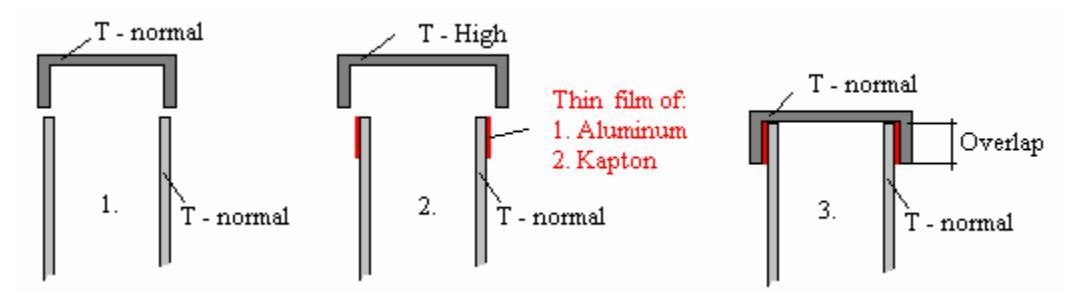
To make the shrink fit connection, the end cap was heated in a Glass Lab annealer to a high enough temperature that it could fit over the cylinder. When the cap returned to normal temperature, it shrank onto the cylinder. Figure 4.4-1 illustrates this process.

Figure 4.4-1: Shrink fit process

The attachment procedure was designed to take advantage of the thermal expansion properties of materials. By heating up a metal such as aluminum 100 °C it will expand approximately 0.2%. In our case with an end-cap ID of about 6 inch (15 cm) that result in an expansion of 0.3 mm. The cylinder OD was larger than the end-cap ID at room temperature, so to be able to fit the end-caps onto the cylinder, it was desired to get a large gap as possible between them. The melting temperature of the aluminum and the Kapton film put constraints on how much we could expand the end-cap. The temperature of the liquid nitrogen (LN) limited the shrinking of the cylinder.

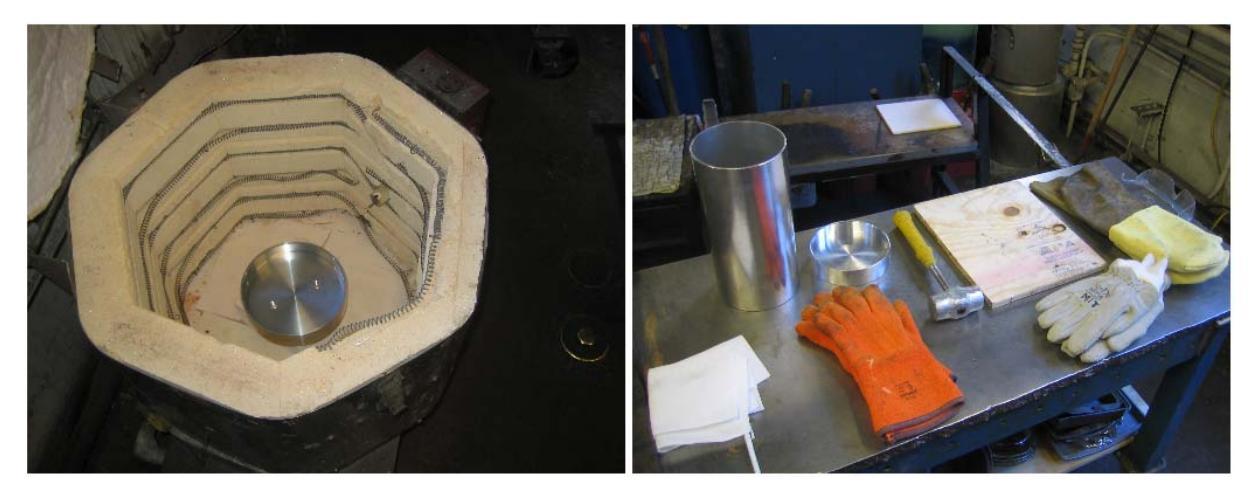
The tank without Kapton was put together first. We heated up the end-caps in an annealing oven to 650 °F, and the cylinder was cooled in a steel bucket down to -270 °F with liquid nitrogen (LN). They were then simultaneously taken out of the oven and the bucket. This part of the attachment required at least two persons. The end-cap was put on a heated iron plate by one person with the opening pointing upwards and one end of the cylinder was aligned to the opening by the other person. A sledgehammer was then used to tap the cylinder down into the end-cap. To protect the edges of the cylinder from the sledgehammer, a wooden plate was held in between. A large force was required to attach the two to each other.

Figure 4.4-2 The end-caps were heated in an anneal oven (left). Materials used (right)

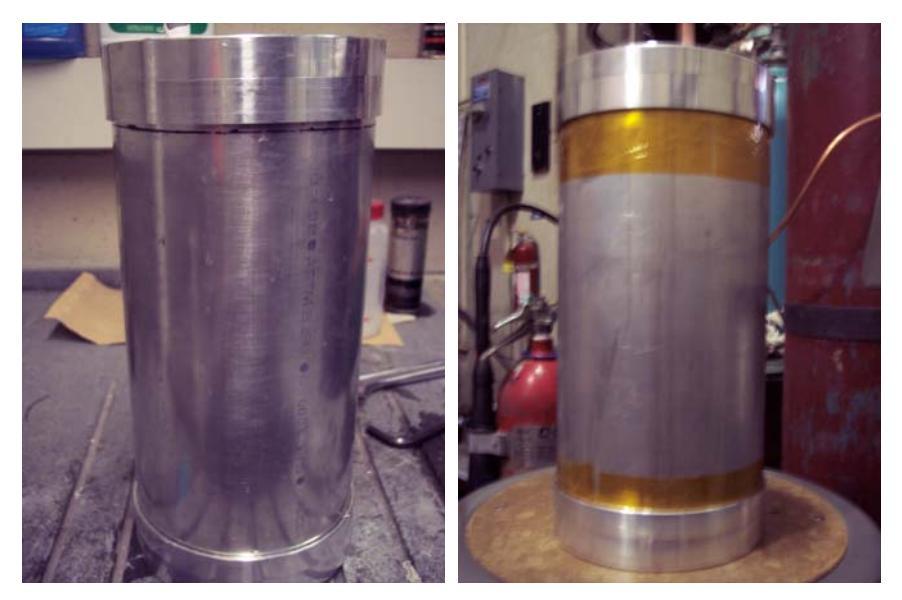
The Kapton film was wrapped around the cylinder edge and held in its place by a metal coil. The end-caps where heated in the annealing oven and the cylinder was, differently from the non Kapton design, cooled in a Styrofoam chest with LN. Because of this, the LN did not boil off quickly, and the cylinder was cooled to a lower temperature than the non Kapton case. Two different approaches were used to try to prevent the Kapton from sliding down along the cylinder during attachment. With the first end-cap, only half of the film was in contact with the cylinder and the other half was above the end. During the attachment of the second end-cap, the Kapton was aligned to the edge of the cylinder. Only a slight touch with the sledgehammer was required to make the end-caps slide over the cylinder ends.

The whole tank was heated in the oven at a temperature of 670°F for about 6 minutes. This was done to melt the Teflon layer on the film so that an adhesive bond would be created in the overlapping surface.

Figure 4.4-3 The tank without Kapton (left) and the one with Kapton film between the cylinder and the end-caps (right).

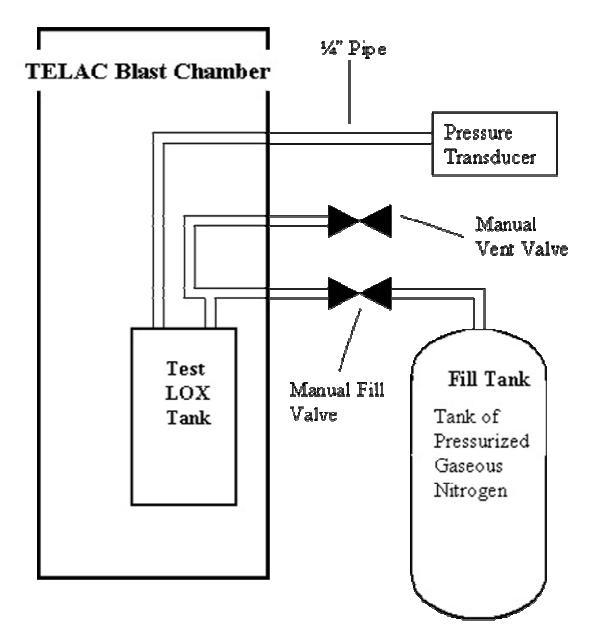
The two tanks were tested in the Telac Lab blast chamber. One of the holes in the tank was connected to pressurized gaseous nitrogen and a manual relief valve. The other hole was connected to a pressure transducer. (See Figure 4.5-1) The pressure transducer was calibrated to a specific voltage by the staff in the Telac Lab. Labview recorded the transducer output with a frequency of 2/second. Table 4.5-2 gives the test matrix for this experiment.

Figure 4.5-1 Test setup in Telac Lab

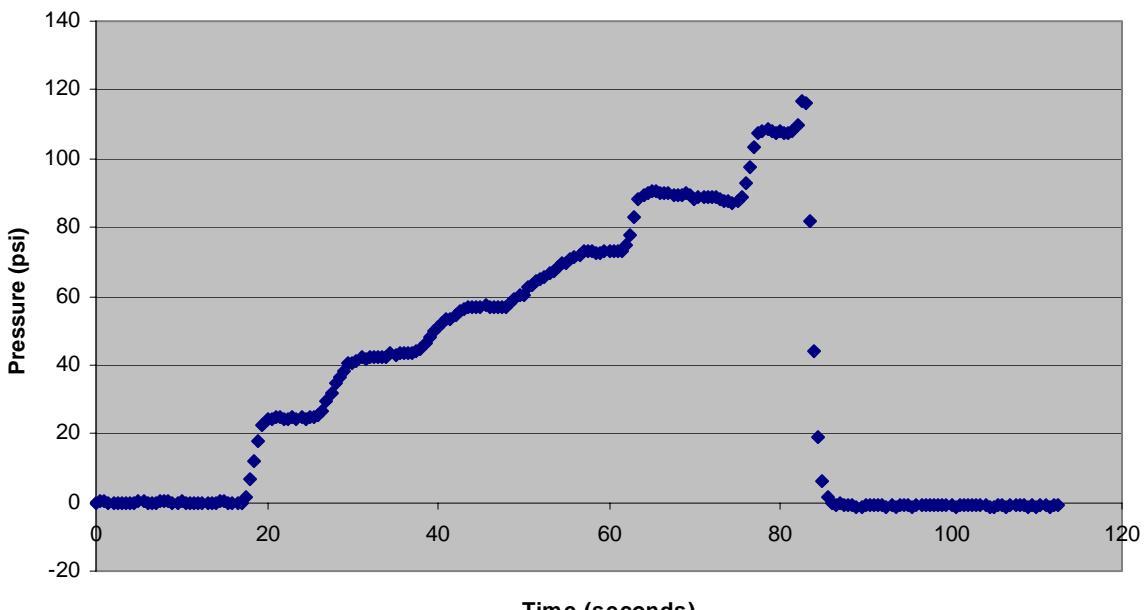
The Kapton tank was hydrostatically tested once. Figure 5.1-1 shows the test results. The tank failed at 117 psi, and then the pressure inside the tank dropped sharply. Also during the test, water droplets showed that the tank was leaking from the cylinder-dome connection.

Figure 5.1-1 Pressure Measurements from Kapton Hydrostatic Test

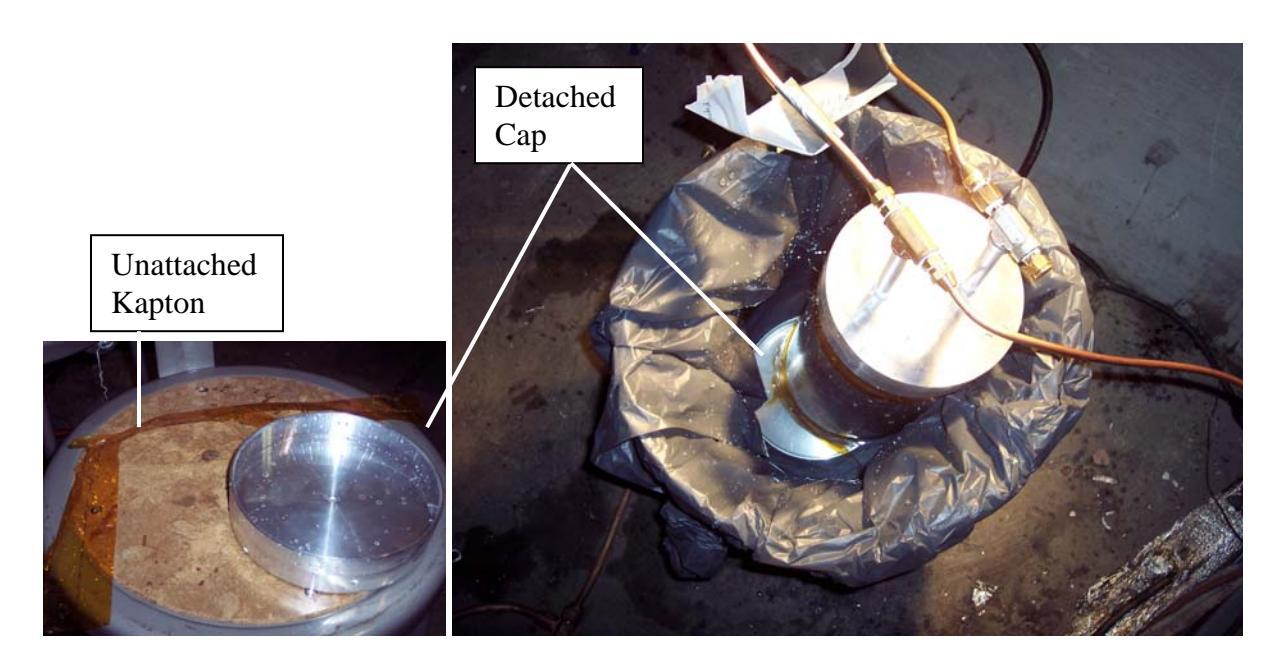
As shown in Figure 5.1-2, inspection of the tank after the test showed that the bottom end cap of the tank popped off the cylinder. The Kapton did not stay attached to either the cylinder or the cap, which means that it probably did not bond to them.

Figure 5.1-2 Post-Test Inspection

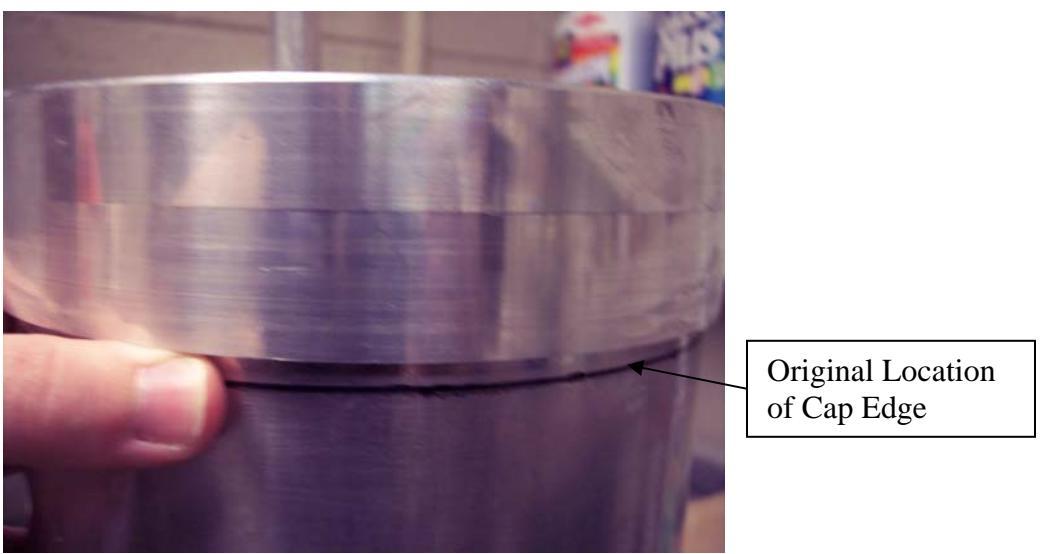
The tank that did not have any Kapton passed two hydrostatic tests, and burst at 176 psi during a cryogenic test. During the first hydrostatic test, the top end cap of the tank popped up about 3/16 in. at 120 psi. Figure 5.2-1 shows this. A possible reason why this occured is that the cap was misaligned.

Figure 5.2-1 Cap Popped Up From Original Position

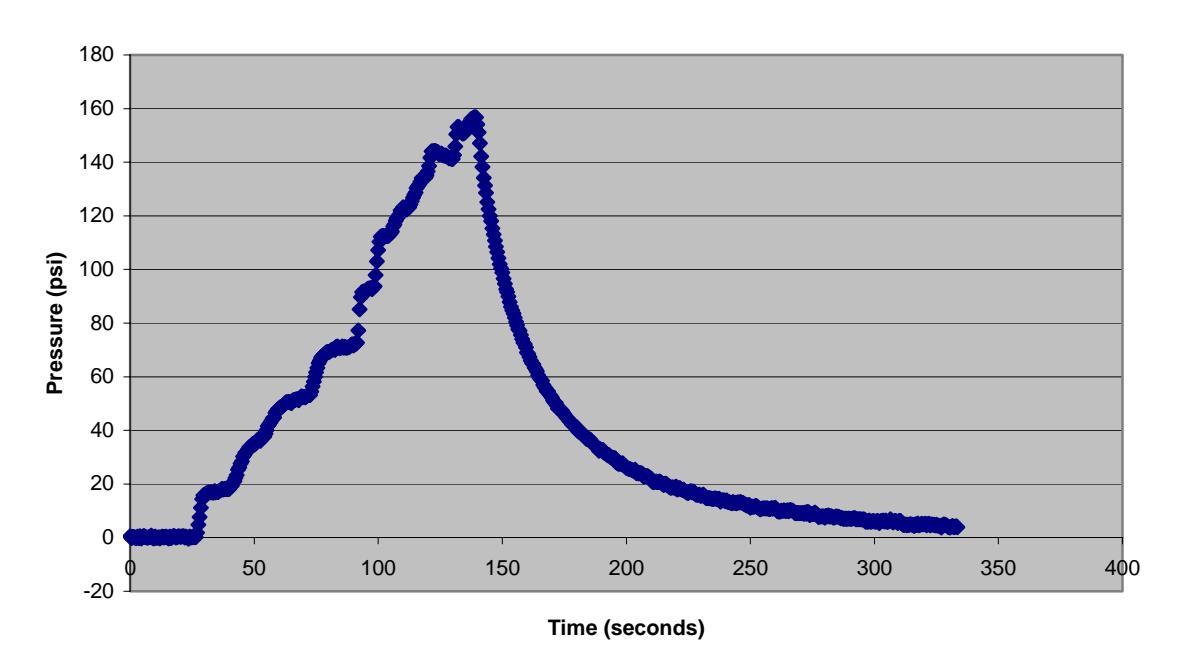
We continued to pressurize the tank to 150 psi, and then shut off the pressure source. This tank also leaked through the cylinder-cap connection. The gradual pressure drop in Figure 5.2-2 is caused by this leaking.

Figure 5.2-2 Pressure Measurements from No Kapton Hydrostatic Test 1

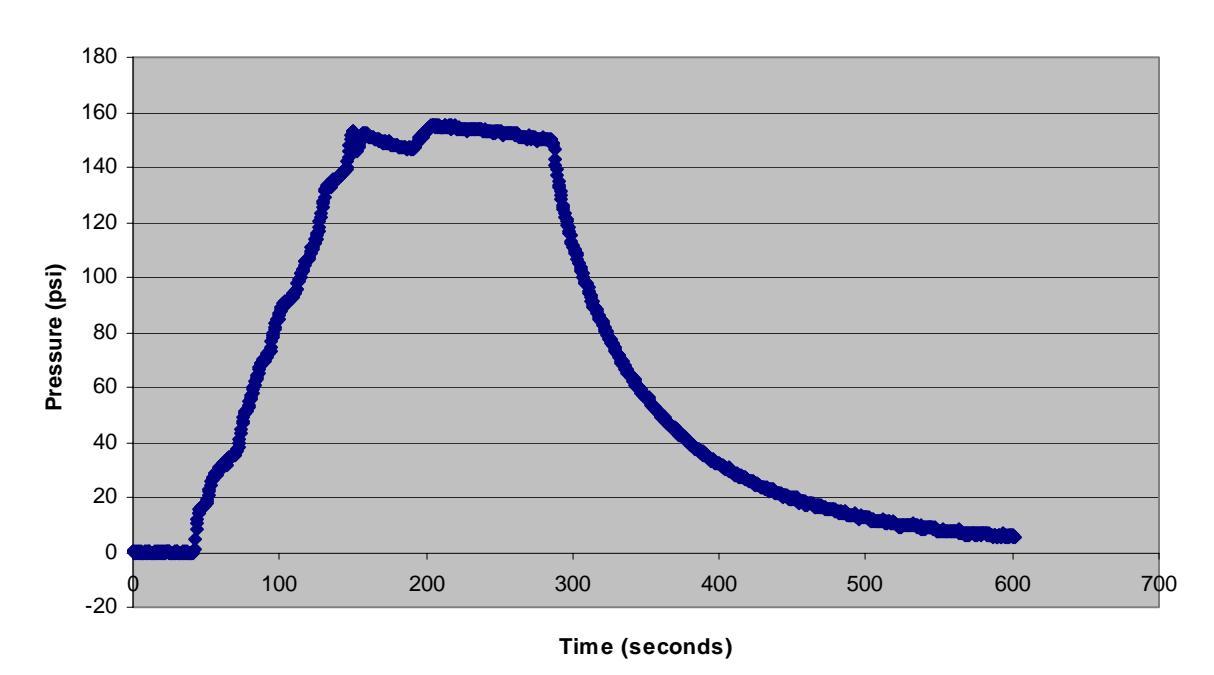
To ensure that the tank would hold 150 psi without the cap moving farther, the tank was hydrostatically tested a second time. This time, we continued to pressurize the tank to keep the pressure around 150 psi for 139 seconds. This can be seen in Figure 5.2-3.

No Kapton Hydrostatic Test 2

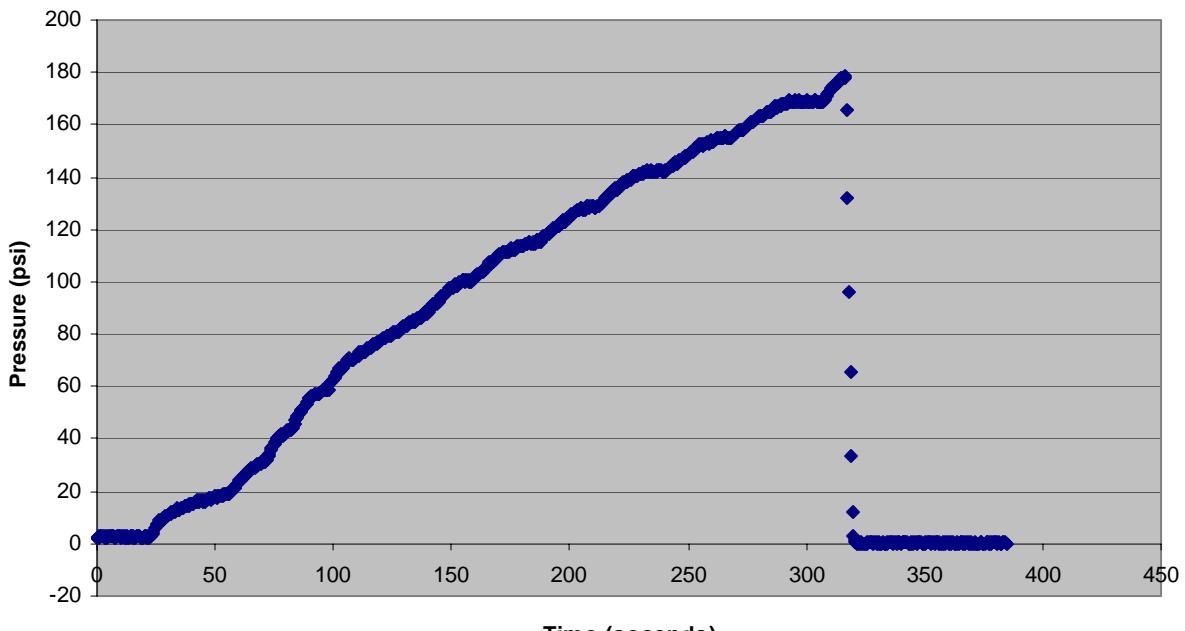
Then a cryongenic test was performed on the tank without Kapton. During this test, the tank failed at 176 psi, as shown by the rapid pressure drop in Figure 5.2-4. The top cap exploded off the cylinder, and landed a few feet away (see Figure 5.2-5).

Figure 5.2-4 Pressure Measurements from No Kapton Cryogenic Test

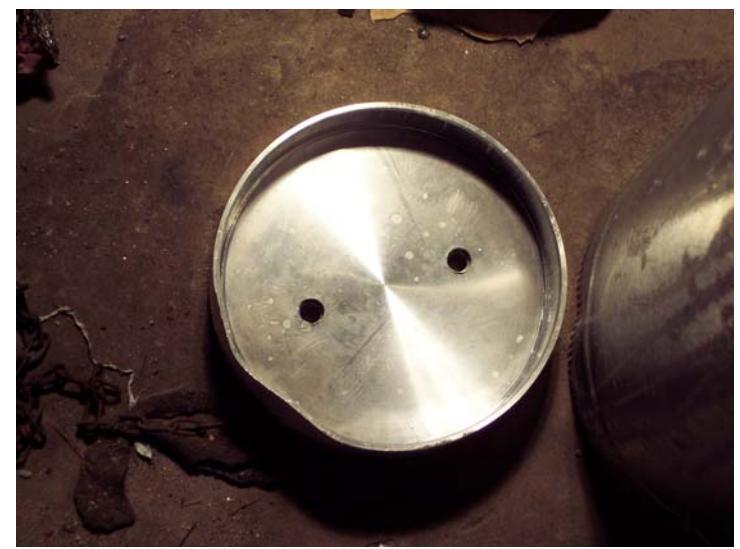
Figure 5.2-5 Detatched Top Cap

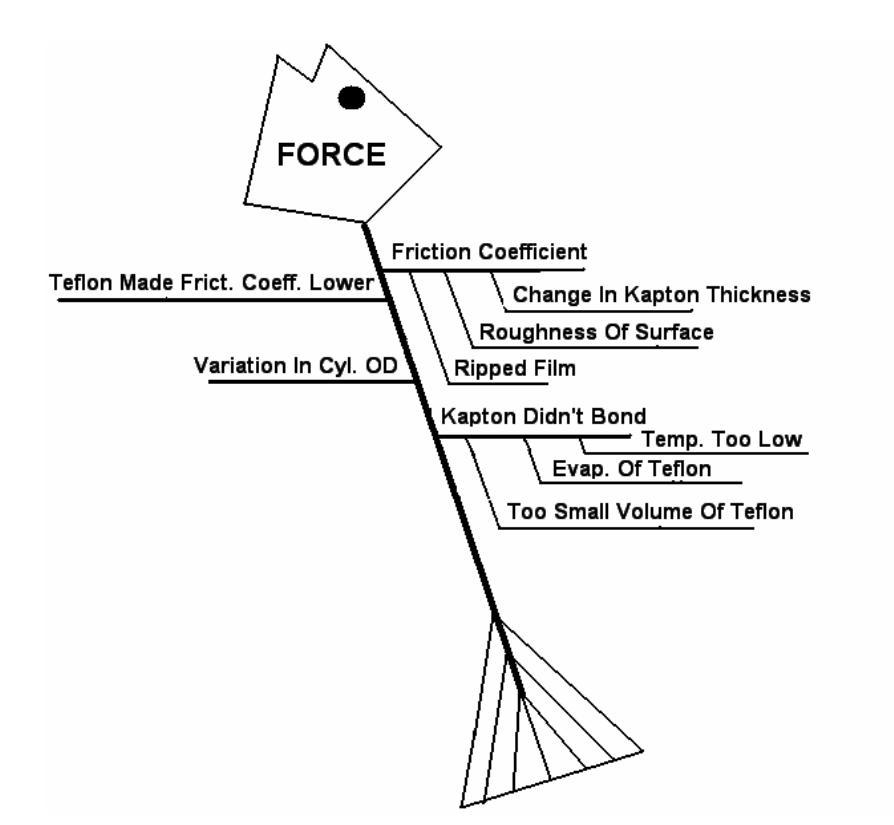
The possible reasons why the Kapton tank failed below the proof pressure and the non Kapton tank failed below the design pressure of 200 psi are presented in this analysis.

Figure 7.1-1 Fishbone analysis of possible reasons why the Kapton cap did not hold the proof pressure

During the design phase of this project, the friction coefficient was estimated to 0.4. The burst pressure is linearly depending on the friction coefficient and an error of 12 % in the estimation of this could alone have been the factor that caused the non Kapton tank to burst at 176 psi instead of 200 psi. Little knowledge about the roughness of the surface in the overlap between the end-caps and the cylinder makes this factor a likely source of error.

For the Kapton design, it is possible that the Teflon layer on the surface of the film never melted or it evaporated and did not bond. If the Teflon didn't melt, the friction coefficient should have been around 0.04 between Teflon and aluminum. ⁵ According to the excel program (See Appendix A), the burst pressure would have been 20 psi in this case. Variation in the overlap force could have made this burst pressure vary, but not as much as 600 % (which would have been required to hold 117 psi). Thus, the possibility that the Teflon made the surface slippery is therefore not a likely cause of the low burst pressure.

If the case were that the Teflon evaporated, there would have been two changes in the seal. The film would have been 0.001 inches thinner, thus making the force in the overlap lower. According to the excel model, the burst pressure would then be about 180 psi. Also, the surface between the aluminum and the leftover Kapton film would have had a different friction coefficient, causing the tank to fail below 180 psi. Thus, a possible reason why the Kapton tank failed at a lower pressure than expected was that the Teflon evaporated and the Kapton had a lower coefficient of friction than 0.04.

The cylinders used in this experiment had an average diameter 6 in., but the outer diameter variations were large (\pm 0.035 in.). This could have affected the contact surface between the endcaps and the cylinder and could have invalidated the assumption that the two surfaces where in contact with uniform pressure distribution. If the surfaces were not deformed because of this, the friction force would not have changed, but since aluminum is a soft metal, the probability is high that there was a deformation of the overlapping surface. Evidence of this was found while examining the surface of the cylinder after the tank was tested. The contact surface on the cylinder had stripes of metal scratched of in axial direction. This could have been formed during the attachment of the caps or as a result of the growing force in the overlap when the end-cap and the cylinder temperature reached equilibrium. These variations could have thus lowered the burst pressure and made it impossible for the Teflon to bond to the metal.

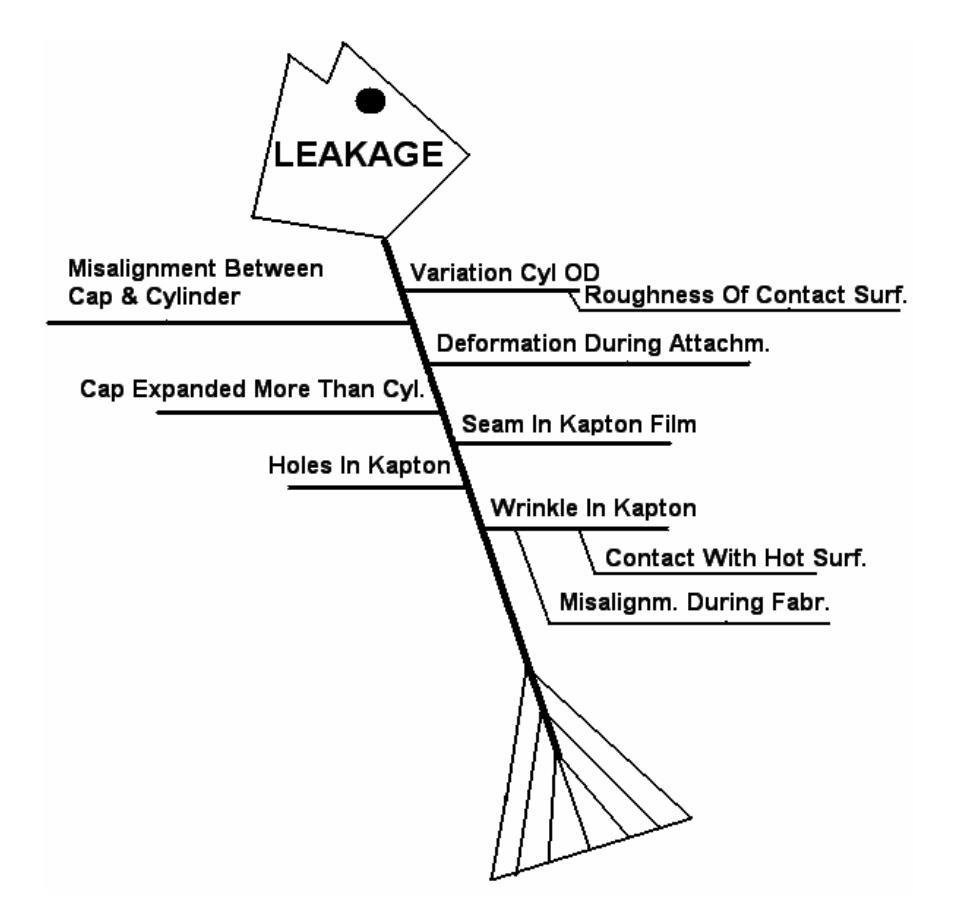
During the pressurization of the tanks, they both leaked. The different ways the leaks could have occurred are discussed in this section.

Figure 7.2-1 Fishbone analysis of possible reasons for leakage

As discussed in section 6.1, the cylinder had high variations in the OD. This was very likely the reason why the tanks leaked. Areas with no contact between the end-caps and the cylinder could have vented out the high pressure in the tanks.

Also, There could have been misalignment between the end-caps and the cylinders. A small misalignment could have created channels for the nitrogen to flow through. Another way these channels could have occurred was during the quite violent attachment of the non Kapton tank with the sledge hammer, or because of wrinkles in the Kapton film and the open seam of the film for the Kapton tank. An over expanded end-cap is not a likely cause, since a high pressure inside

the tank should have tightened the sealing rather than opening it, and the end-caps had a very rigid (0.5 inch) top surface.

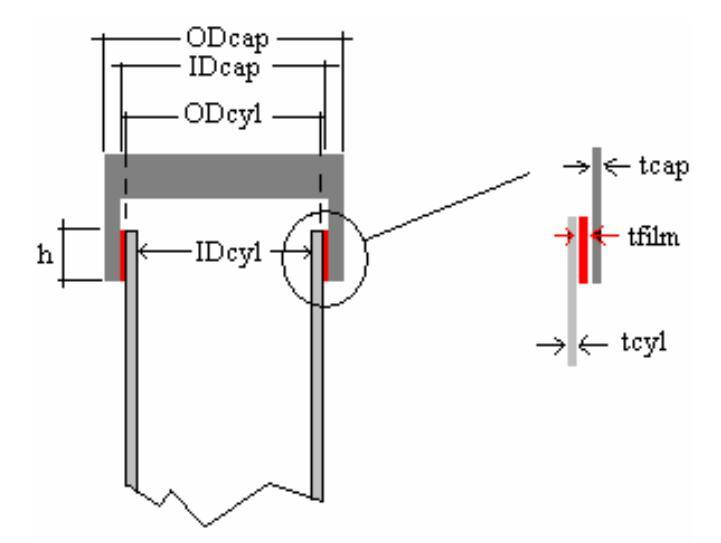
Figure A-2 Dimension Symbols for Tank

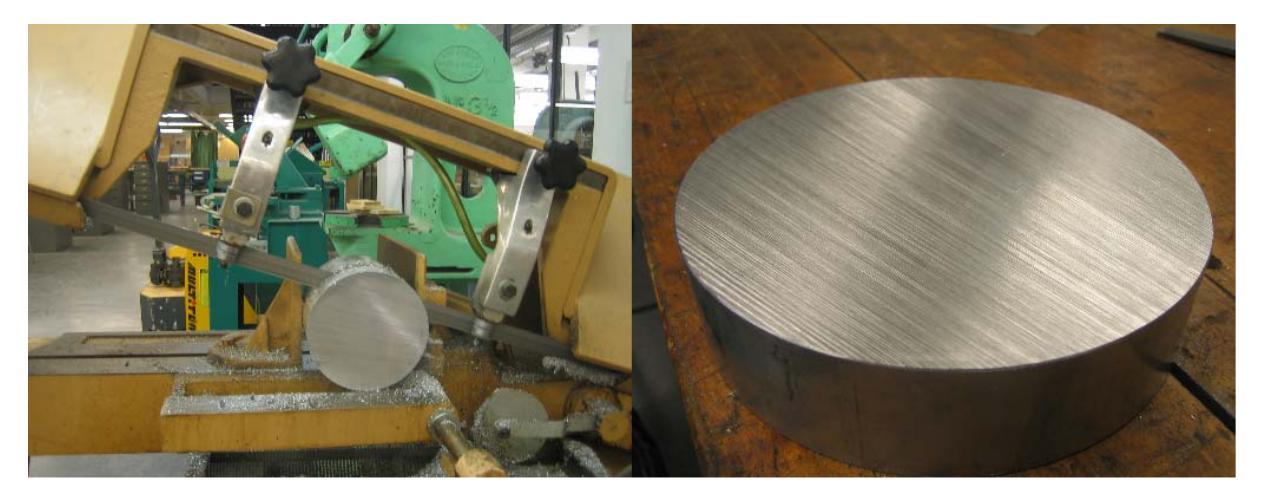
The solid cylinder (SC) had to be cut in to 5 discs (4 original plus 1 spare) with the band-saw in the machine shop. A final thickness of 1.5 inch was desired for the end-caps, so the discs where cut to a thickness of 1.75 inch to cover for the band thickness of 1/16 inch. The band was lubricated by applying wax from a wax stick onto the band. It had to be applied before the band passed through the SC, since it could cause the band to slip if applied after the cutting. This was done every minute of the sawing with an increase in frequency when passing the thick regions of the SC. When cutting a thick SC the saw could start tugging. This happened a few times and could be resolved by relieving some of the pressure from the weight of the saw. The edges of the discs where pretty sharp and were therefore blunted with a file and some sandpaper to reduce the risk of personal injuries during the rest of the fabrication. Each disc required 28 minutes of sawing (6.5 inch SC) and 2 minutes of blunting.

Figure C-1 Five 1.75 inch thick discs were cut from a 1 foot long solid cylinder wit ha band-saw (left). The discs had sharp edges and where blunted with a file and sandpaper (right).

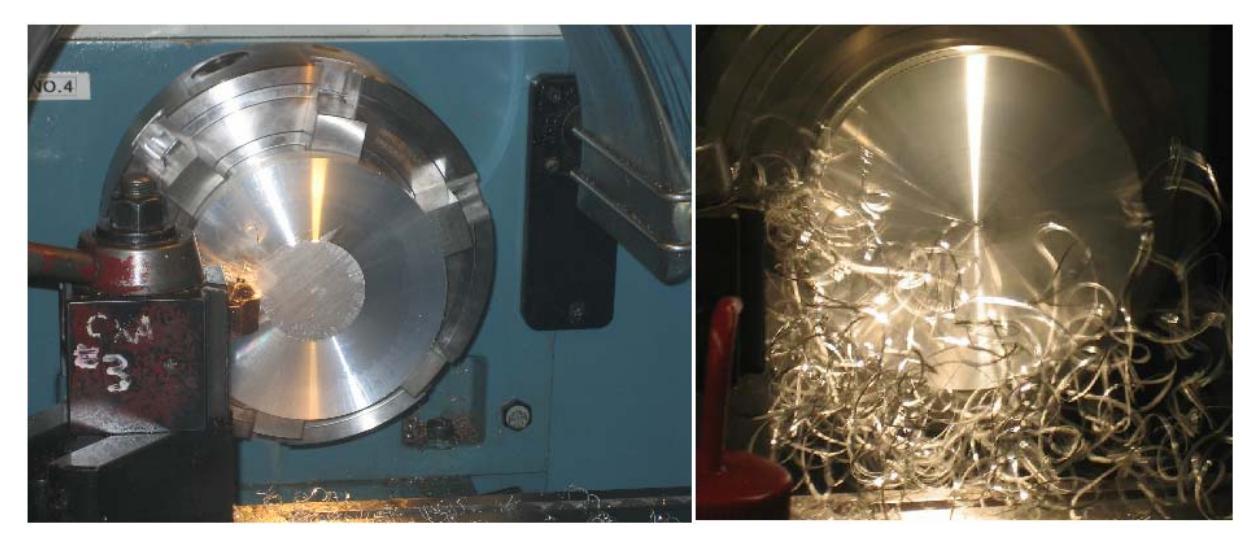
The discs were place in the lathe and the coordinates were set in the computer. Thin layers where cut of the discs until a thickness of 1.5 inch was obtained. Large and long pieces of spiral-shaped aluminum was spinning around during this step, so extra caution was taken and surfaces near the spinning discs where cleaned.

Figure C-2 The outside of a disc was machined down to the outer shape of an end-cap during the first step in the lathe.

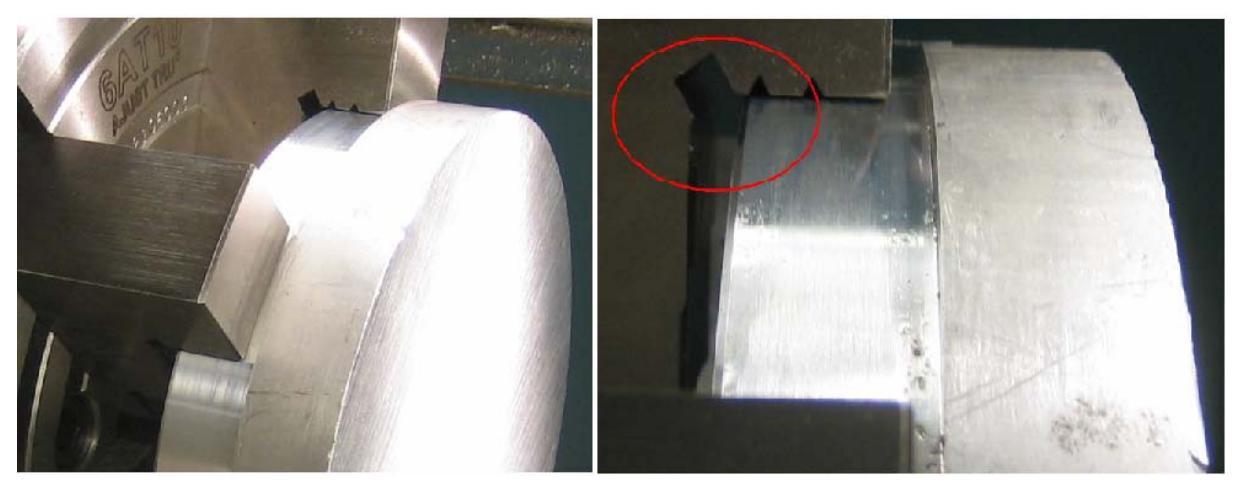
About half of the OD could be removed before flipping the discs in the mount. The depth of the mount was larger than the axial length of the adjusted OD. This caused some concern about alignment of the discs axis with the lathes axis of rotation. To solve this problem, three steel pieces of accurate similar dimensions were used in between the bottom of the mount and the flat surface of the discs. This step took about 45 min to 1 hour per disc.

Figure C-3 A disc with half of the OD removed. Pieces of metal were put in (centre of red ellips) between the discs and the bottom of the lathe mount to align disc-axis with lathe axis of rotation.

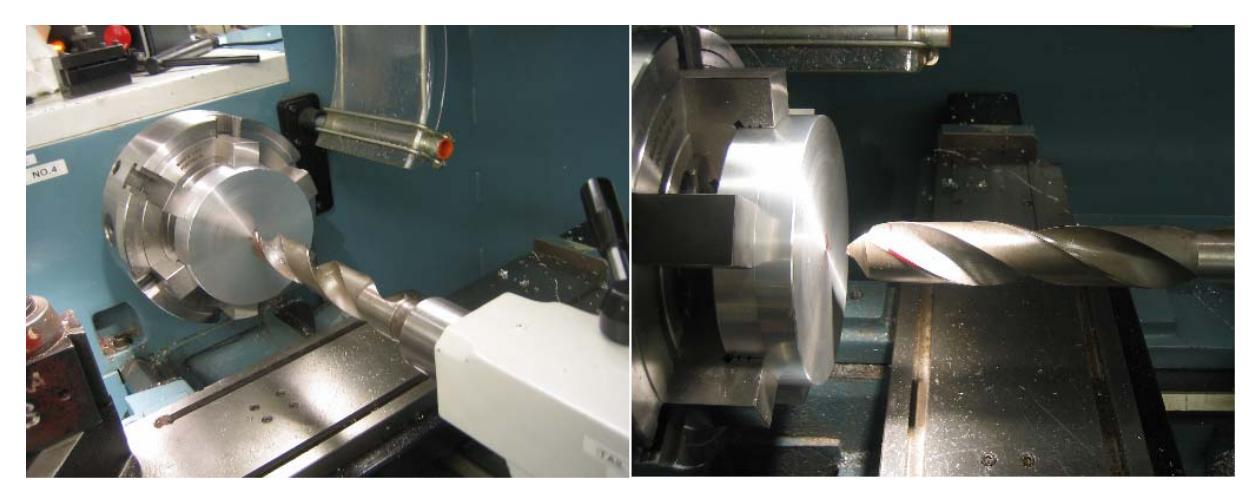
Before taking out the inside, a hole was drilled in the centre of the discs. This was also done in the lathe, using a different tool than when layers were cut off. The deepest part of the hole drilled in this step had the shape of a cone, and had to be adjusted to a cylinder shape.

Figure C-4 A one inch deep hole was drilled in each of the end-caps using the lathe. A red line painted on the drill marked where to stop.
